Hydrocarbon Fuel/Combustion- Chamber-Liner Materials Compatibility

Contract NAS 3-25070
Interim Final Report
NASA CR-185203
April 1990

Report No. KBQ-FR-1
NASA CR-185203

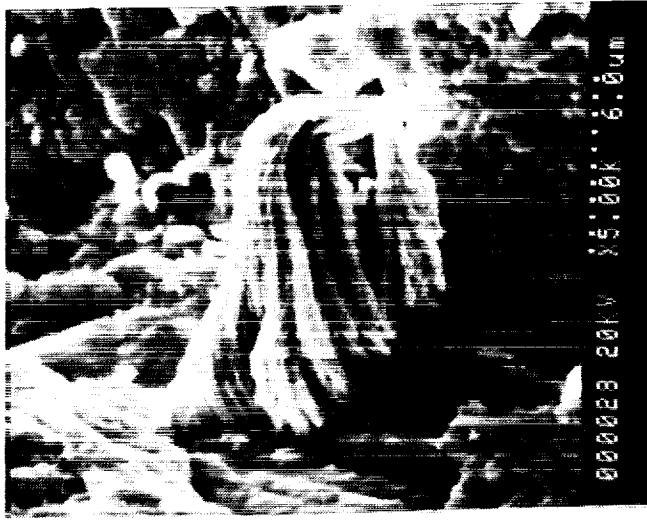
Figure 31c. Channel Wall at 5000x
